SAFETY BULLETIN
January 17, 2018

Man Lift Mfg. Co., (“Man Lift”) issues this Safety Bulletin related to the following Explosion Proof boom lifts manufactured by Man Lift during the period from January 2011 - January 2018 due to two (2) A60EX and one (1) A80EX booms (fielded in 2013) being found to have failed or cracked welds in the mid-post area of the lower boom:

Affected Models:

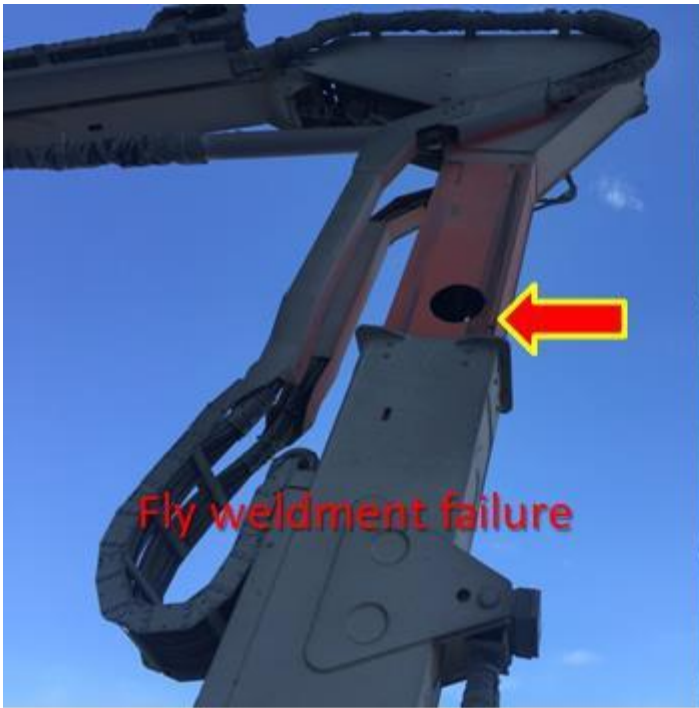
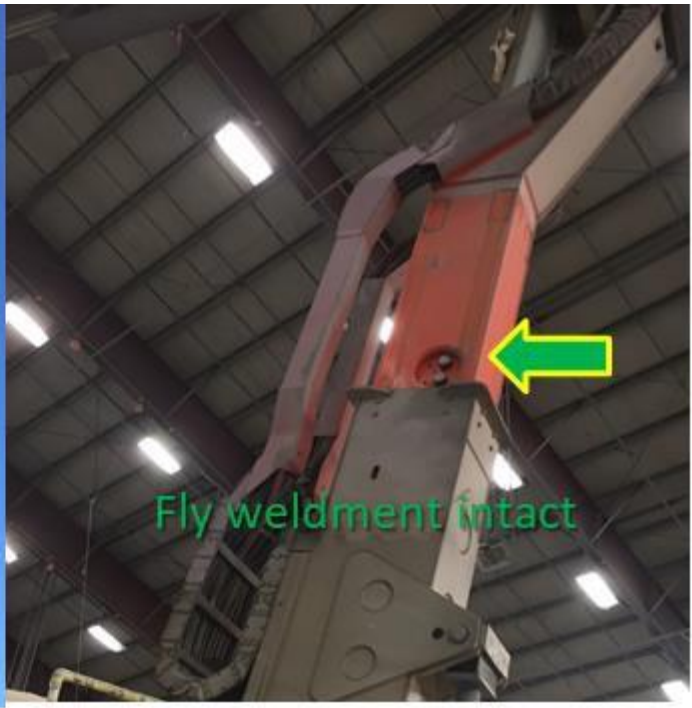
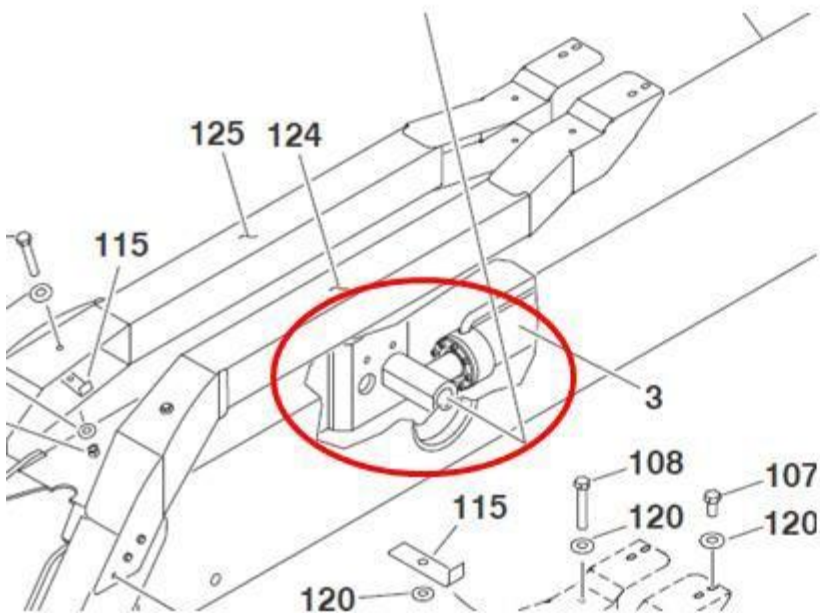
Figure 1.

Weld failure and cracking of the Tower Boom Fly weldment at the Tower boom extend cylinder and upright level cylinder attachment pin plate.

A60EX is shown for reference only. Inspection area same for both A60EX & A80EX.

Man Lift recommends that each unit carrying one of the above Model Numbers be removed from active service until the inspection has been completed and corrective steps are taken, if necessary. Note: Failure to inspect the lifts can result in potential failure similar to the ones previously noted and may result in serious injury or loss of life. Please reference figure 1 to aid in identifying the inspection area.
